## NISSAN RL4FO2A AND RE4FO2A SOFT 1-2 UPSHIFT

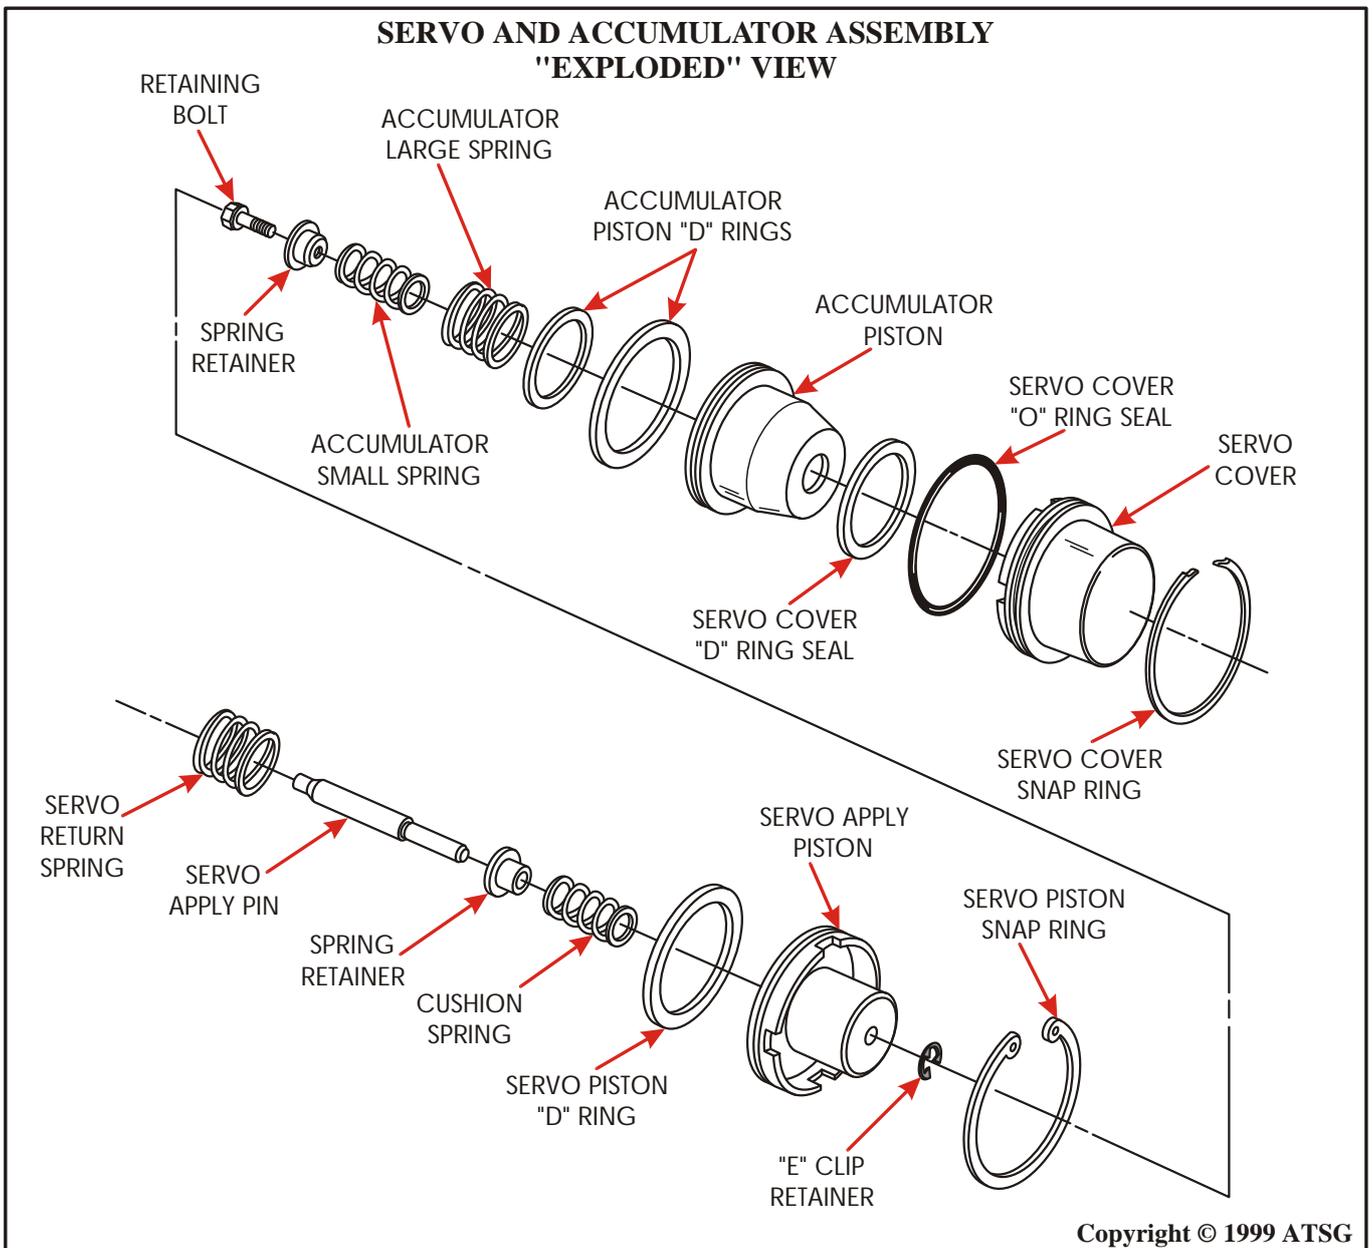
## SERVO AND ACCUMULATOR ASSEMBLY "CUT-AWAY" VIEW

**COMPLAINT:** Soft and/or a Slide-Bump 1-2 upshift on Nissan vehicles equipped with the RL4FO2A or the RE4FO2A transaxles.

**CAUSE:** The cause may be, too much accumulator piston movement.

**CORRECTION:** Remove and discard the large diameter accumulator spring as shown in Figure 2. Use the illustrations in Figure 1 and 2, to ensure proper reassembly.
