# Technical Service Information

## NISSAN RE4R01A / RE4F02A SOFT OR FLARED UPSHIFTS

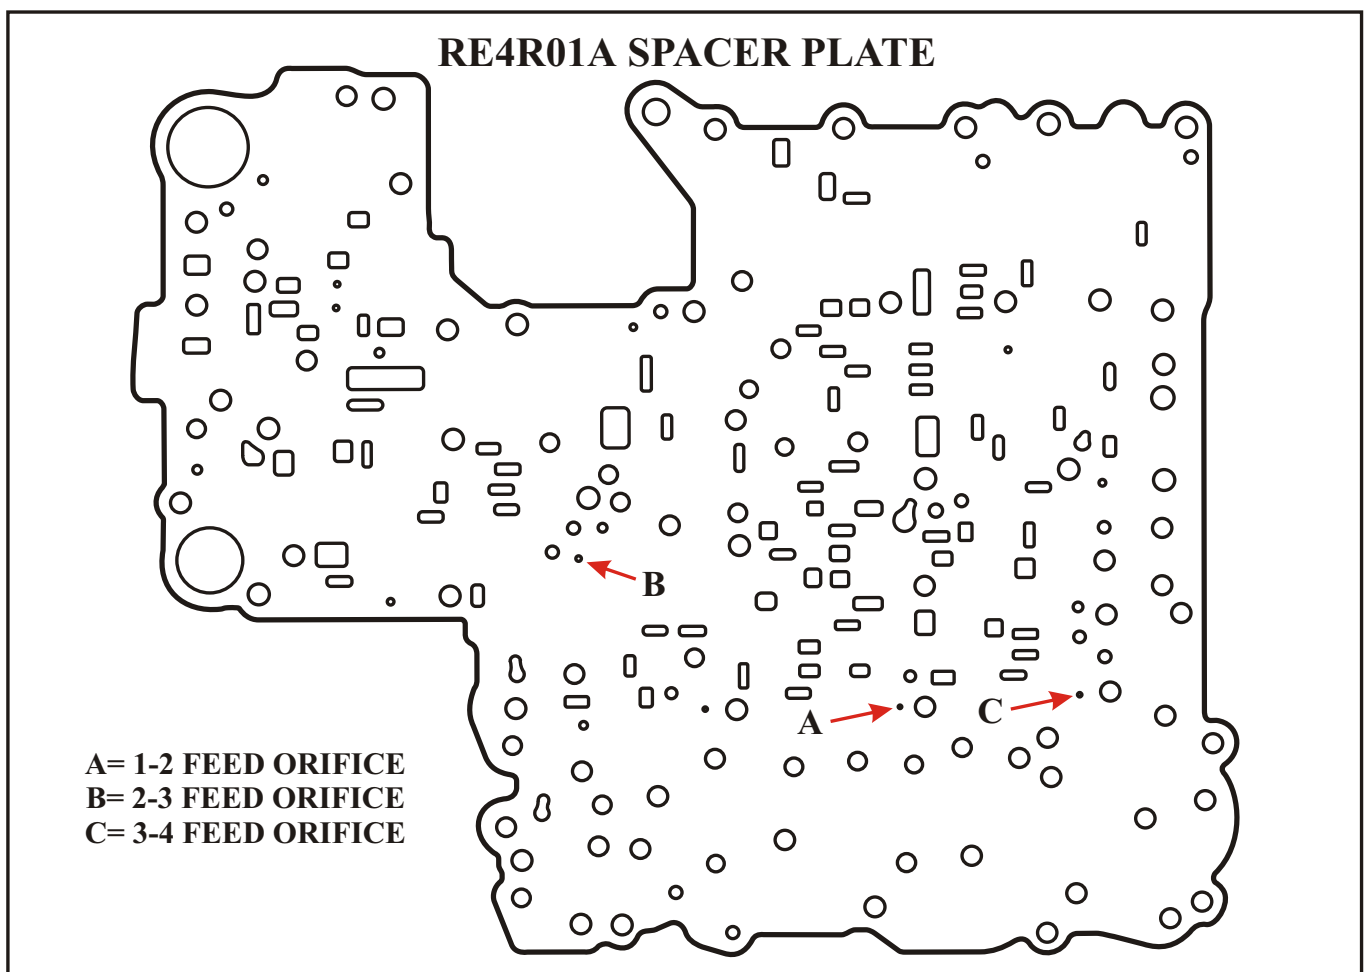
**COMPLAINT:** After overhaul, vehicles equipped with RE4R01A or RE4F02A transmissions, may exhibit soft or flared upshifts.

**CAUSE:** The cause may be, insufficient feed oil to the clutch or band servo related to the upshift taking place.

**CORRECTION:** Refer to Figure 1 for RE4R01A feed orifice locations. Refer to Figure 2 for RE4F02A feed orifice locations. To firm the upshift in question, enlarge the orifice marked in the spacer plate .020“- .030” larger.

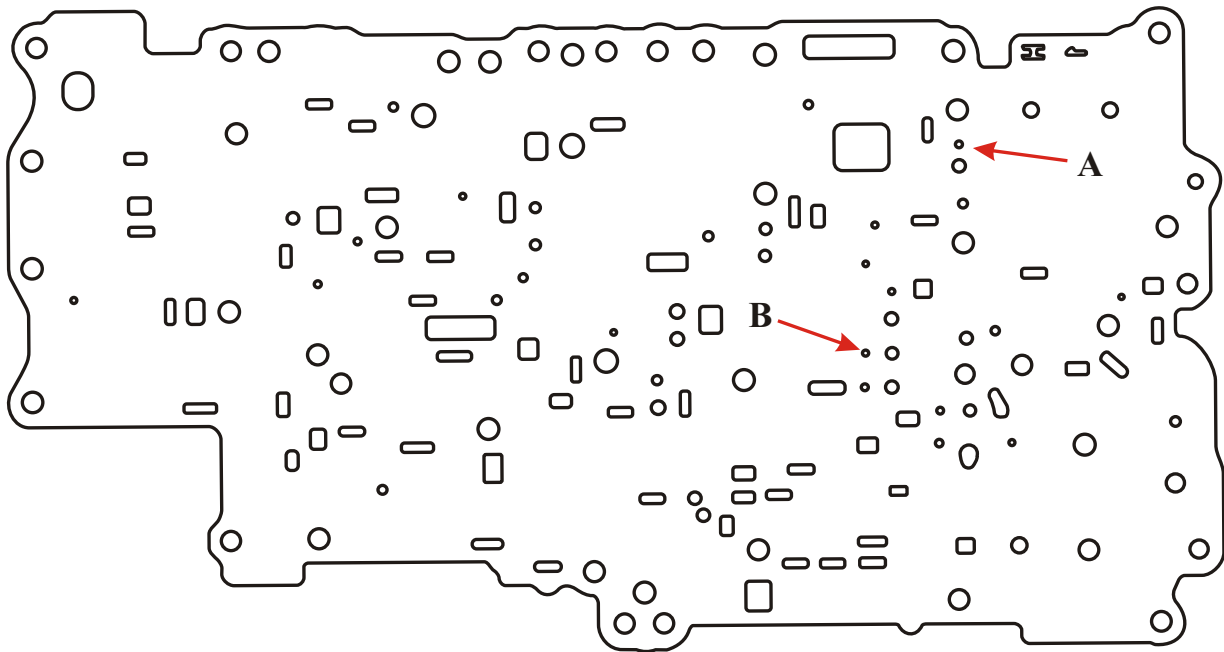
Figure 2

**A= 1-2 AND 3-4 FEED ORIFICE**  
**B= 2-3 FEED ORIFICE**
